# Manhole Inspection Summary

Manhole # S29MM\_001MH

Insp Date: **7/11/07 10:13 AM**

**Location** Address: **2100 RESERVOIR ST**

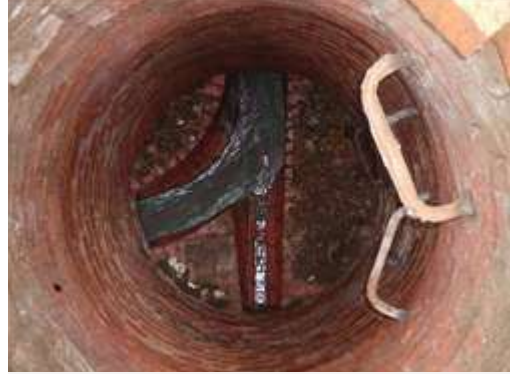
Top View

☒ **Debris** (not Condition related)

Count: **5** Missing: **0** ☒ **Corroded**

Corroded steps. Bench debris.

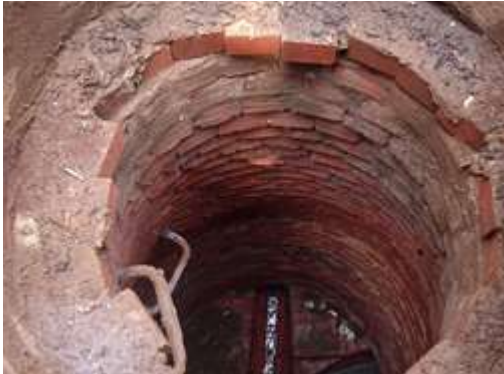
Defect

☒ **Leaks**

Condition: ☐ Sound ☐ Cracked ☐ Root Intrusion ☒ **Loose Brick** ☒ **Deteriorated**

Infiltration: ☐ None ☒ **Joint** ☐ Cracks ☒ **Mortar** ☐ Roots ☐ Wall

Infiltration: ☐ None ☐ Joint ☐ Cracks ☒ **Mortar** ☐ Roots ☒ **Wall**

Frame leaks. Adjustment deterioration, loose brick and infiltration. Barrel infiltration.

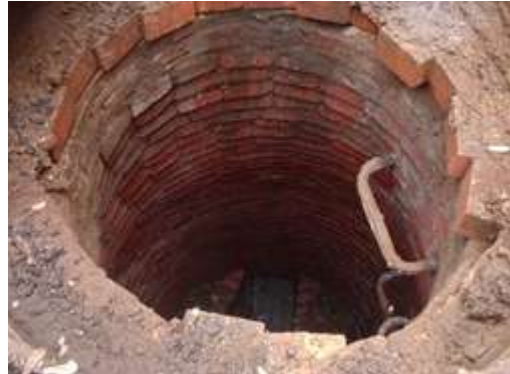
Defect

Adjustment deterioration, loose brick and infiltration.

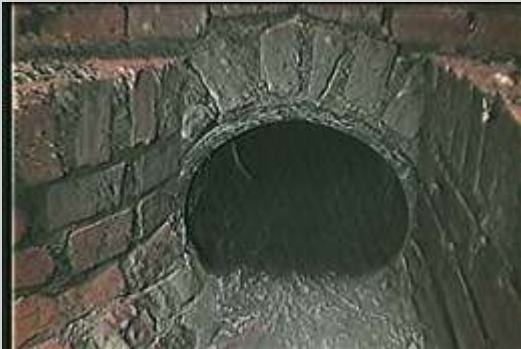
### 12 in. Circular Gravity Sewer Pipe Out @ 12 O'Clock

Infiltration: **None** Pipe Seal Cond: **Cracked**

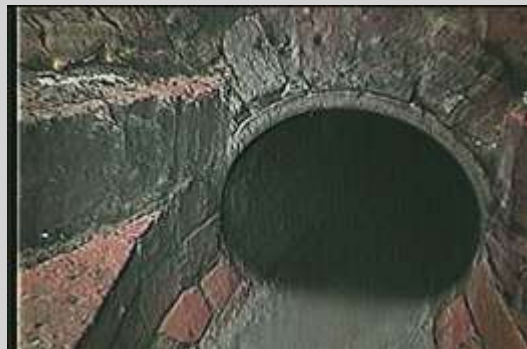
12 in. Circular Gravity Sewer

Condition: ☐ Sound ☐ Cracked ☐ Root Intrusion ☒ **Deteriorated** ☐ Leaks ☐ Debris

Channel deterioration.
